August 10, 2020

Re: Shoreline Park Synthetic Turf Soccer Field Assessment

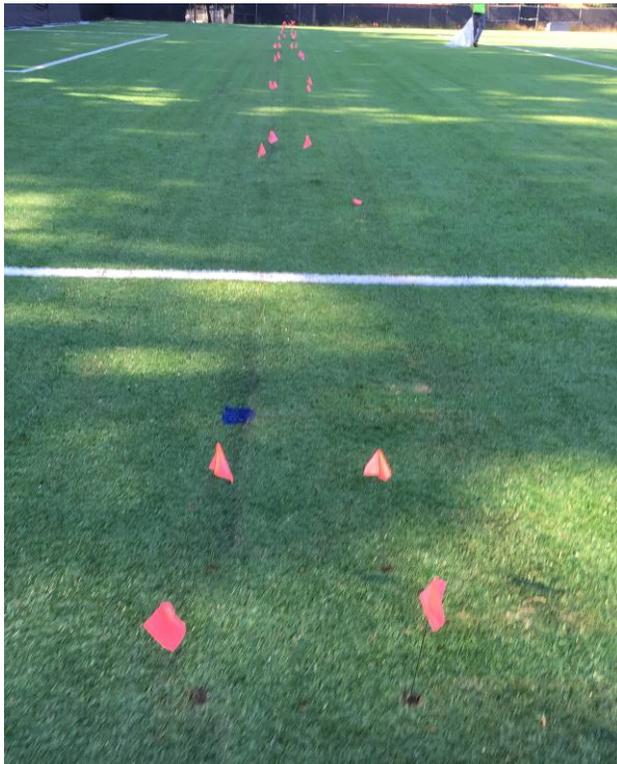
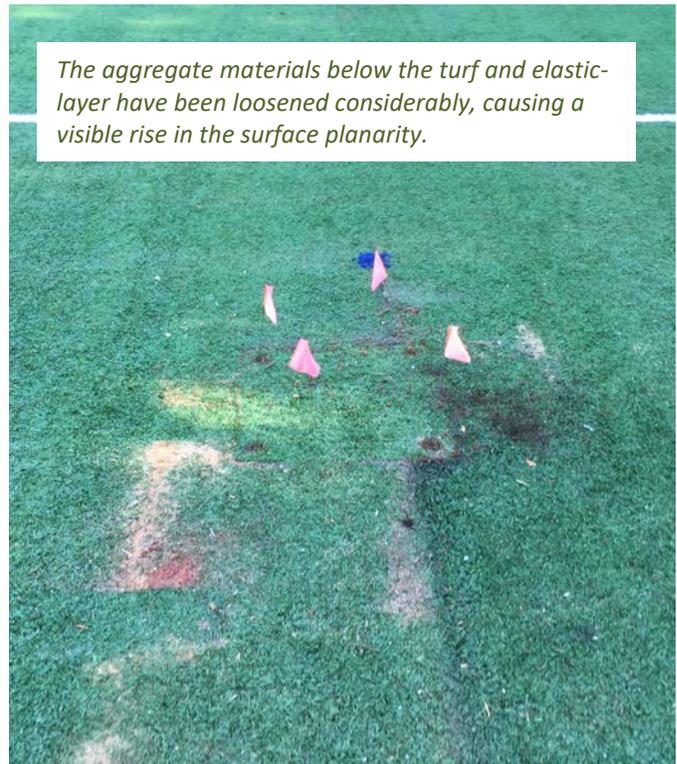
The removal of the support column stakes has damaged the underlying field base profile. Primarily the base damage appears limited to the elastic layer pad with minor displacement of aggregate materials located below the pad. Numerous support column locations across the length and width of the field require repair work. The anchor stake removal process has pulled the aggregate base material and elastic layer pad upward and has left protrusions in the surface synthetic turf.

**Corrective Action: Re-level existing base aggregate and cut and patch elastic layer pad**

Removal of the synthetic turf is required to access the underlying aggregate and pad. Turf removal should occur parallel with the entire synthetic turf panel. The width of the removal strip should be a minimum 3 feet wide in order to allow access to the elastic layer pad below. The cutting of the existing turf will require hand tools in order to preserve the existing fibers bundles that are stitched in the backing. Where ever possible, the cutting should occur between the tufted fiber rows so as to reduce fiber loss and to make the seams less visible after the repairs are completed. We are recommending re-installation of the existing turf as a "patch" to maintain consistent fiber texture and color.

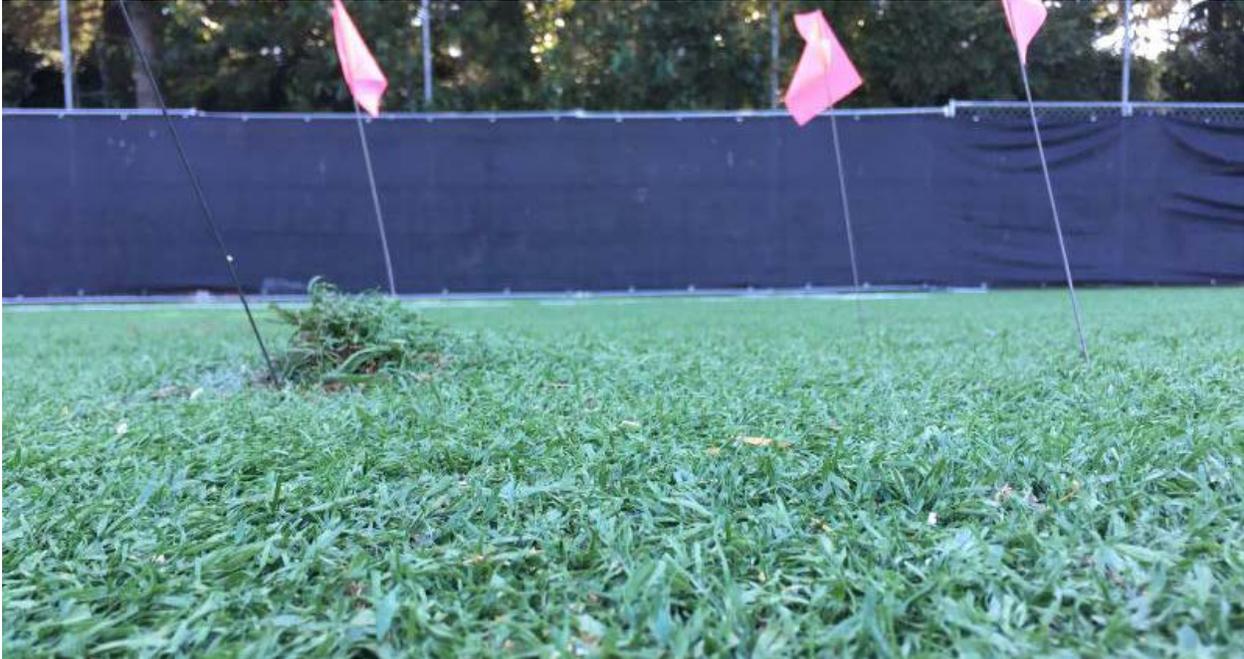
This is one of several dozen locations, each consisting of four stake locations.

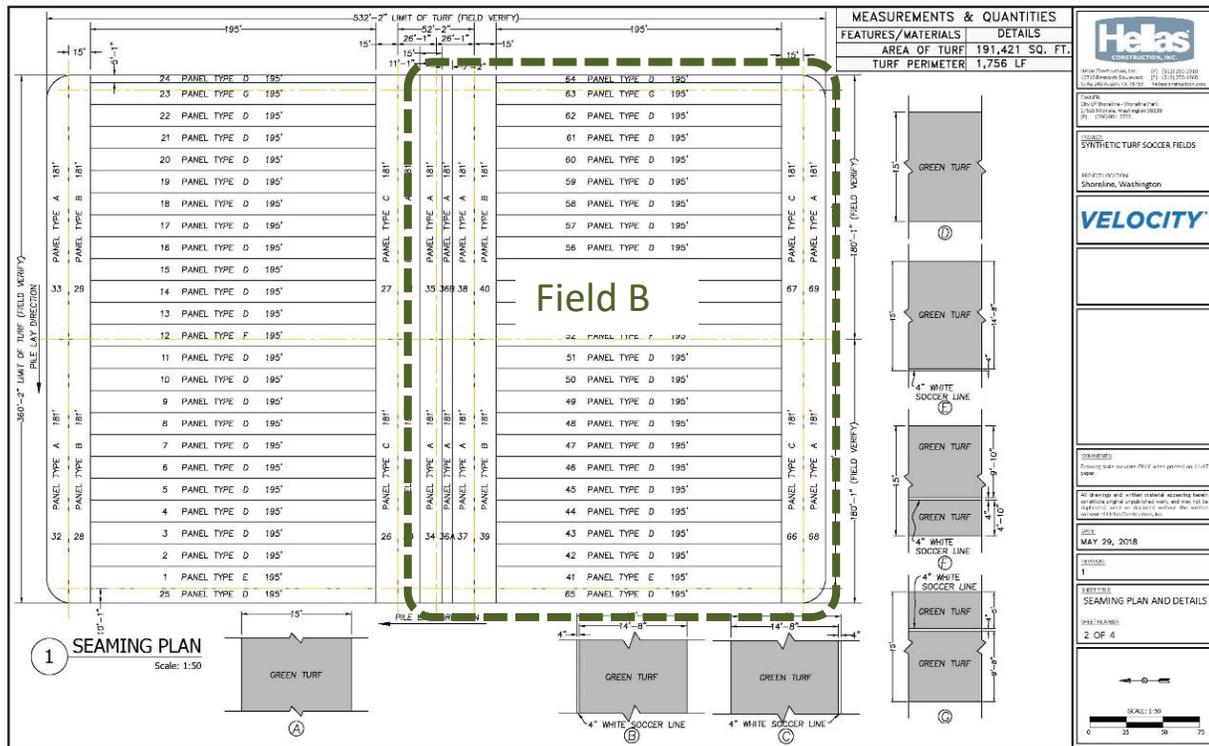
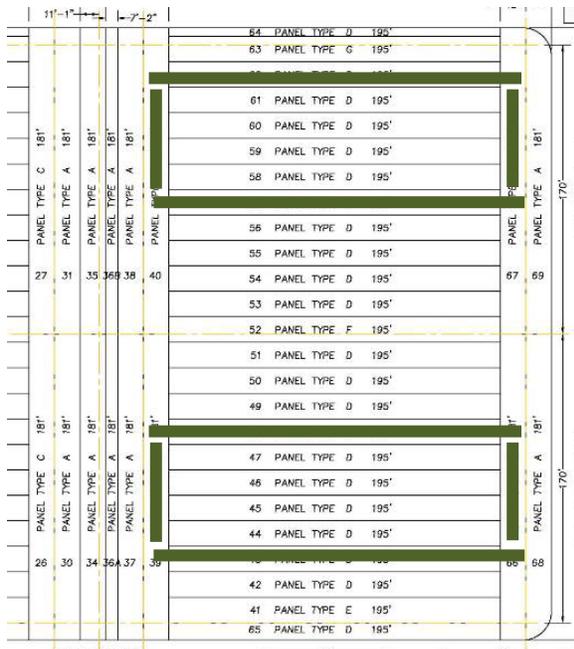
*Approximate pattern and location of turf panel removal and replacement, to access the underlying e-layer and aggregate.*

Where there is a series of repair areas are in alignment with the longitudinal direction of the synthetic turf panels, a strip of synthetic turf can be cut on two sides and removed to provide access to the underlying elastic layer pad. This will include the areas that are aligned in a north/south direction across the width of the field that match the direction of the panels. As there are quarter-turned panels adjacent to the soccer field sidelines that are aligned east/west this may also be the case for the north and south building limits. The panel diagram for the field is shown on the following page and can be referenced for confirmation of the cut strip locations.

For individual repair areas or repair areas that are not aligned with the longitudinal panel direction cutting long strips is not recommended. These repair areas may be accessed by cutting flap on three sides and rolling the turf back while it is still connected on the fourth side.

Once the strips of synthetic turf are fully removed and set aside for reinstallation, a 3' x 3' square of elastic layer pad should be cut and removed at each anchor plate location. Access to the underlying aggregate base materials would be established and allow re-compaction of any disturbed materials. The elastic layer in these locations must be patched with new material to create a level base. In some cases, it may be possible to salvage the elastic layer pad and forego aggregate remediation if the spikes did minimal damage and if the underlying aggregate was not loosened or displaced. However, if the surface is not uniformly level or if the aggregate is no longer consolidated the elastic layer will need to be cut and patched.

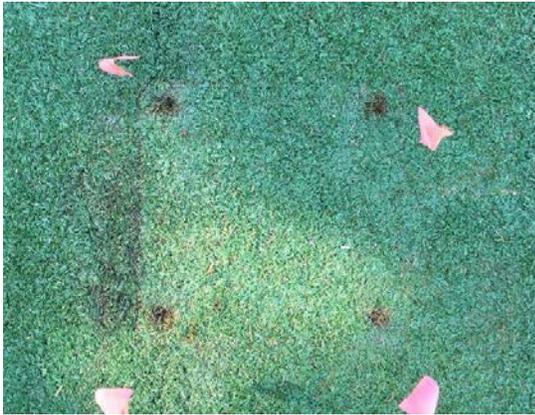
The stakes utilized at the anchor plates have created perforations, holes, and tears in the synthetic turf backing. These areas will create uneven footing and traction and will need to be repaired. They are also unsightly with some residual dirt and rust.

### **Corrective Action: Re-adhere turf were damaged or torn, clean, and trim tall fibers**

The fibers and turf backing material that was displaced and pushed down in these areas when the stakes were driven in must be brought back up to the surface. This can only be achieved from the underside of the turf backing. Once the turf in these areas is rolled back, the displaced fiber and backing will need to be pushed back in place. The In some cases the stake removal resulted in tears in the turf backing or sections of turf that were pulled up. Any tears should be re-adhered to a supplemental backing material (seam tape) to restore the backing integrity. The fiber in these areas should be trimmed as required to provide a uniform relative pile height. The rust and soil staining should be cleaned off of the fibers with a brushing and a mild detergent or soap product. The cork infill cork at locations will need to be re-leveled to provide a uniform and planar surface.

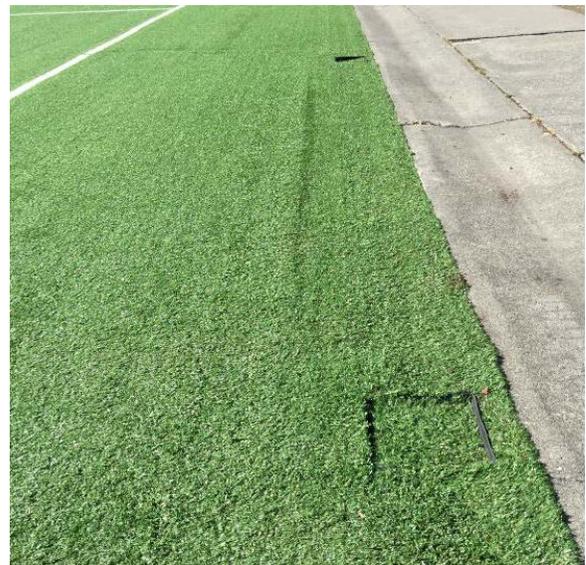
Construction traffic over the soccer goal anchor boxes has resulted in damage. The hardware within the box such as locks and cables would be salvageable however new boxes and lids are required.

**Corrective Action:** Cut existing synthetic turf and elastic layer pad around each box to allow access to box and concrete embedment that exists at both locations. Remove concrete material and damaged box. Place new box, pour concrete, compact aggregate, patch elastic layer pad, glue synthetic turf, and secure turf to edge anchor.

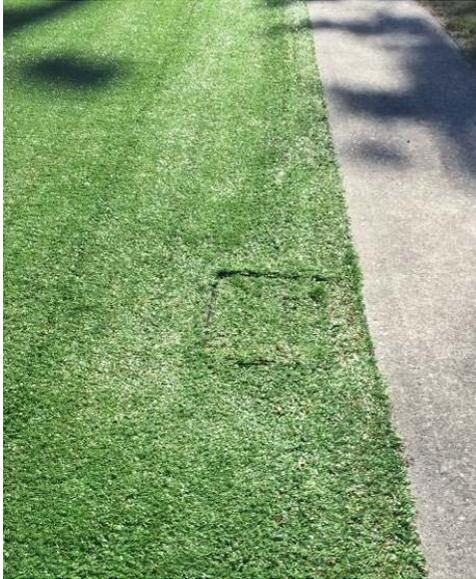
Construction traffic over quick coupling valve locations has depressed and damaged some of the boxes around the perimeter of the field. Potential damage to the valve, riser assembly, and mainline could exist.

**Corrective Action:** Cut existing synthetic turf and elastic layer pad around each box to allow access to box at each location. Remove damaged box. Examine valve for damage and replace if required. Conduct pressure test for field and visual observation of valves to determine integrity of riser assembly and main line pipe. Repair pipe system if leaks observed at valve locations. Place new box, pour concrete, compact aggregate, patch elastic layer pad, glue synthetic turf, and secure turf to edge anchor.

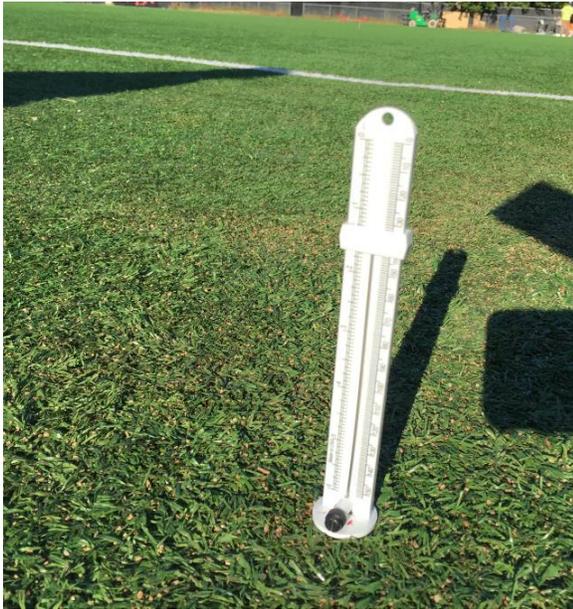
The building locations with the vinyl flooring along with construction vehicle traffic has resulted in compaction of the synthetic turf system. The infill depths measured between 1.00" and 1.25" for the synthetic turf. For reference the infill depths on Field "A" were in the range of 1.25" to 1.5". The fibers for the field have also been matted down across the majority of the field. Significant impact was noted at the construction entry area where infill also contained high amounts of dirt and debris.

**Corrective Action:** Several steps require implementation to improve the synthetic turf.

**Infill Decompaction:** Addressing the compaction of the cork and sand infill within the synthetic turf requires metal tine drag treatment in order to reduce to compacted condition of the infill materials.
